An Taisce
The National Trust for Ireland

Buildings at Risk

November 2014

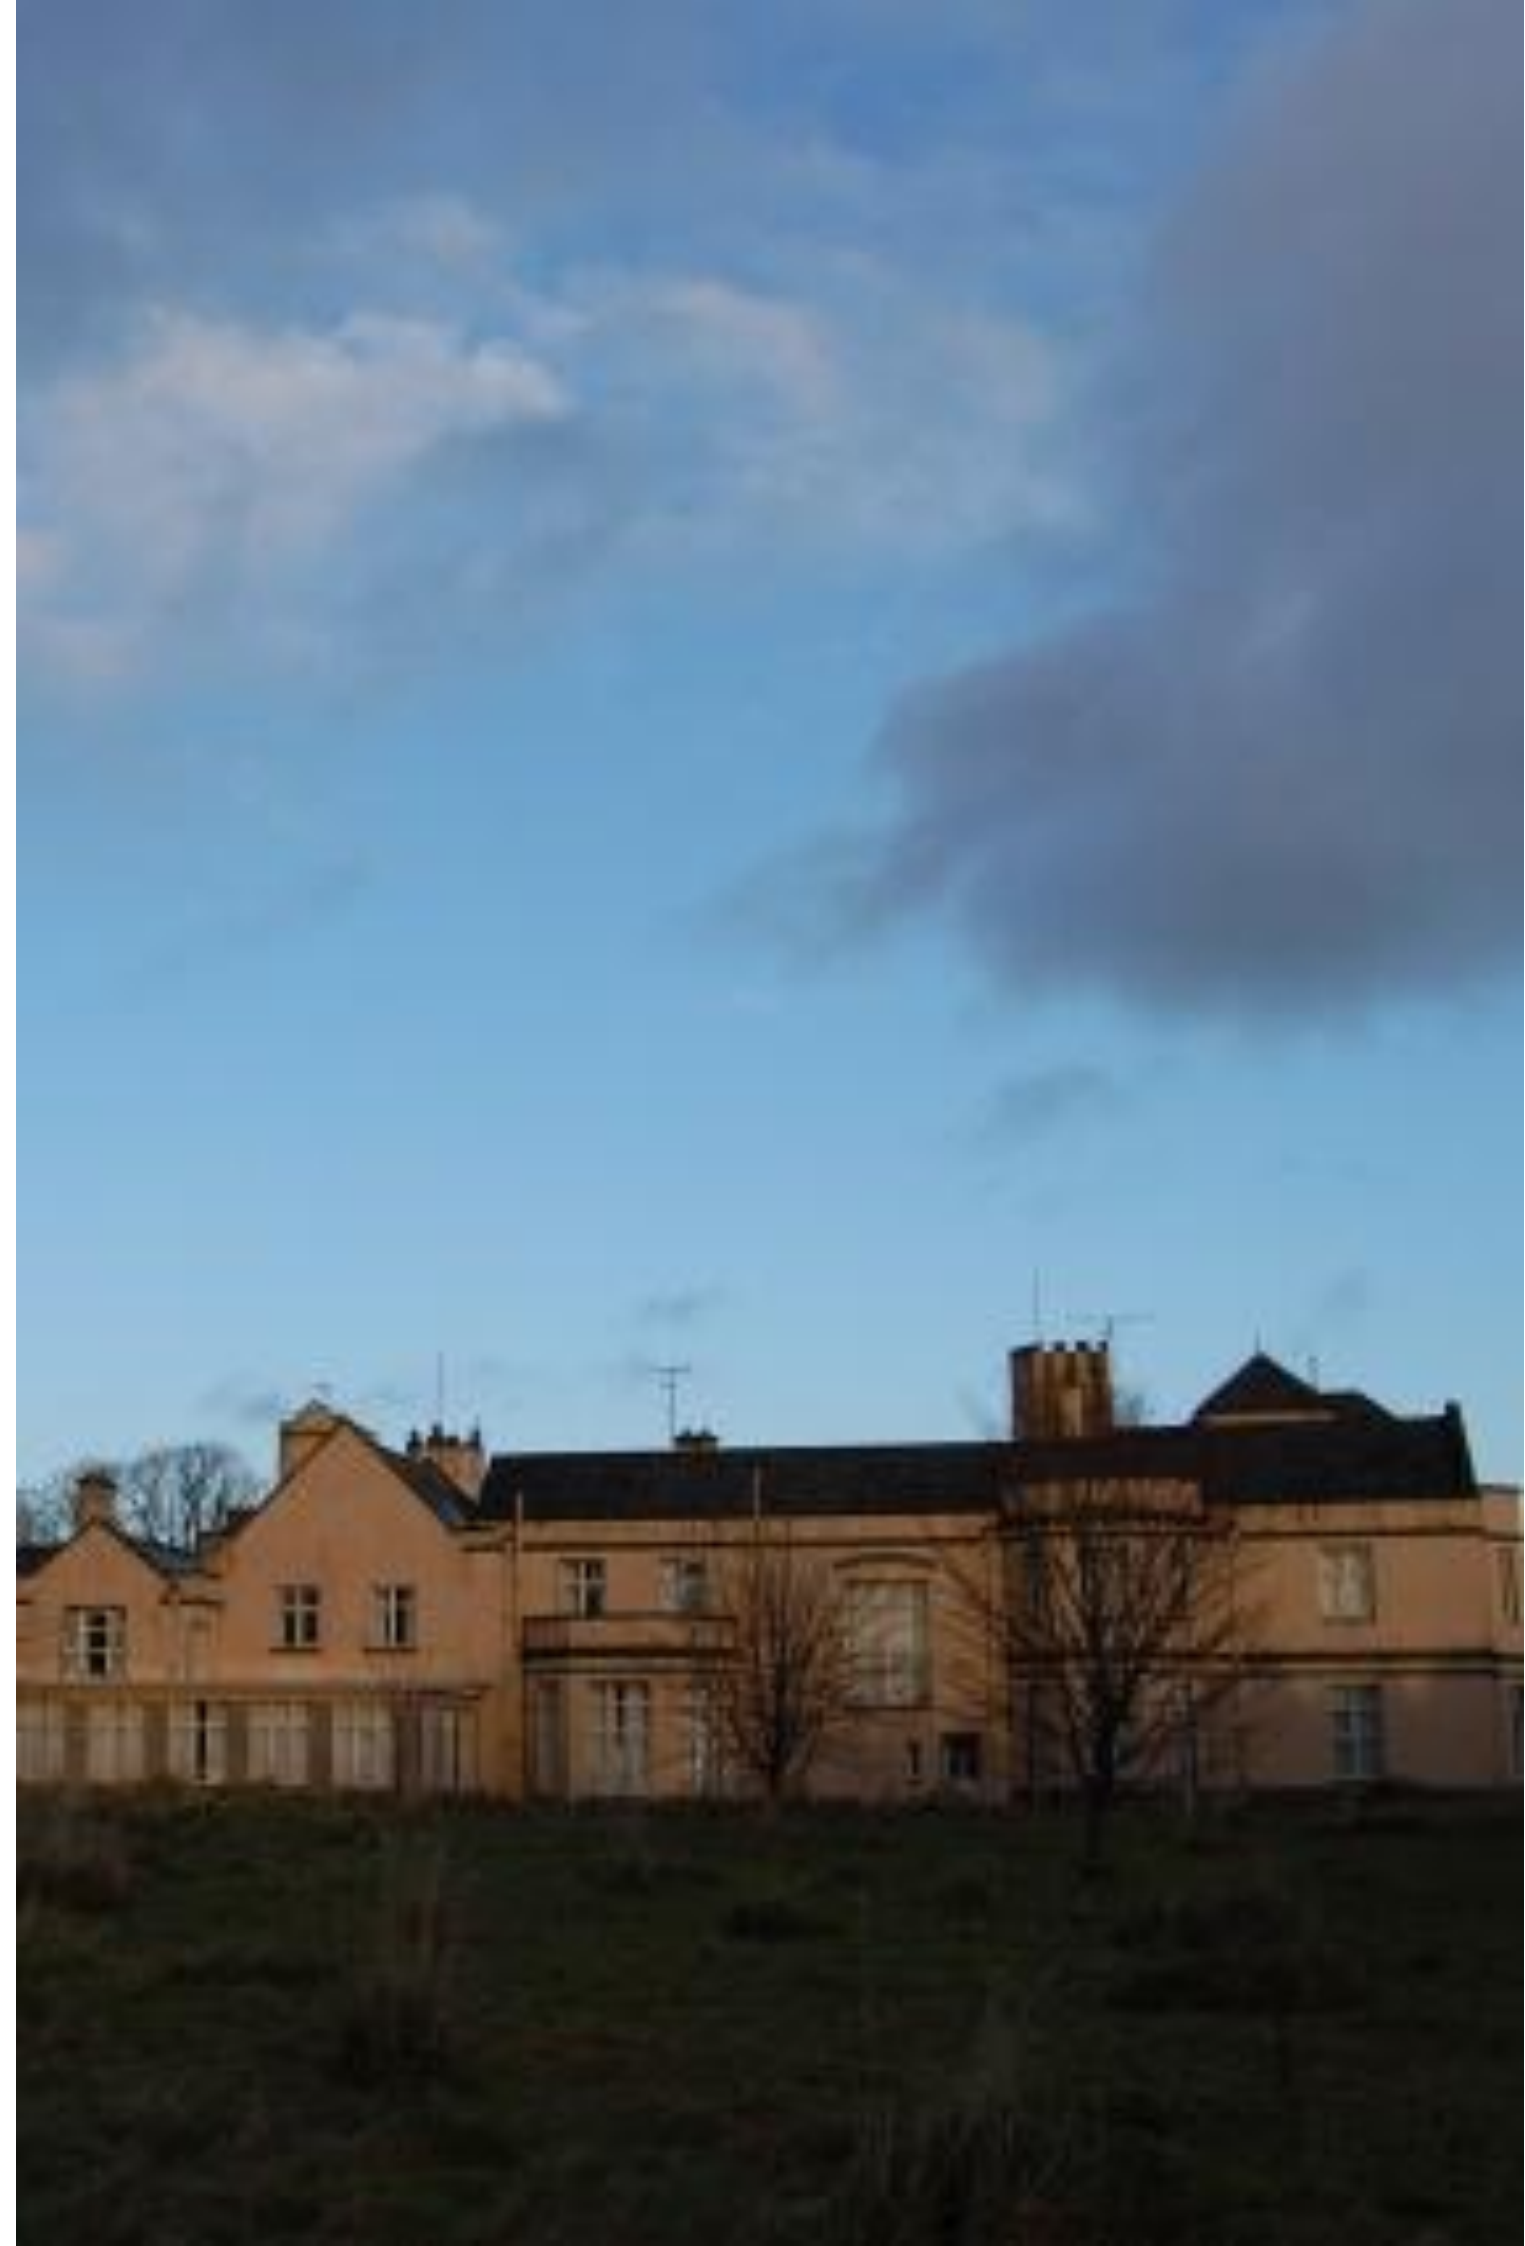
Tobertynan House

Vacant with no identified new use	X
Suffering from neglect and/or poor maintenance	X
Suffering from structural problems	
Fire damaged	
Threatened with demolition	
Ruin which is poorly maintained

Condition of Structure	Poor
Level of Risk	High

This building has been vacant for a number of years and does not appear to be maintained. Most of the external fabric remains, but there are obvious signs of deterioration, particularly due to the extensive quarrying impact on its setting. There is no immediate danger of collapse but the condition is such that unless urgent remedial works are carried out the building will sharply deteriorate.

Tobertynan is a late Georgian house with castellated corner turrets. It was built for the Stackpoole family but has been vacant for nearly a decade. The quarrying to the south of the house (pictured) is increasingly damaging the setting of the house. The structure is of significant historic importance and requires conservation works to prevent further deterioration.

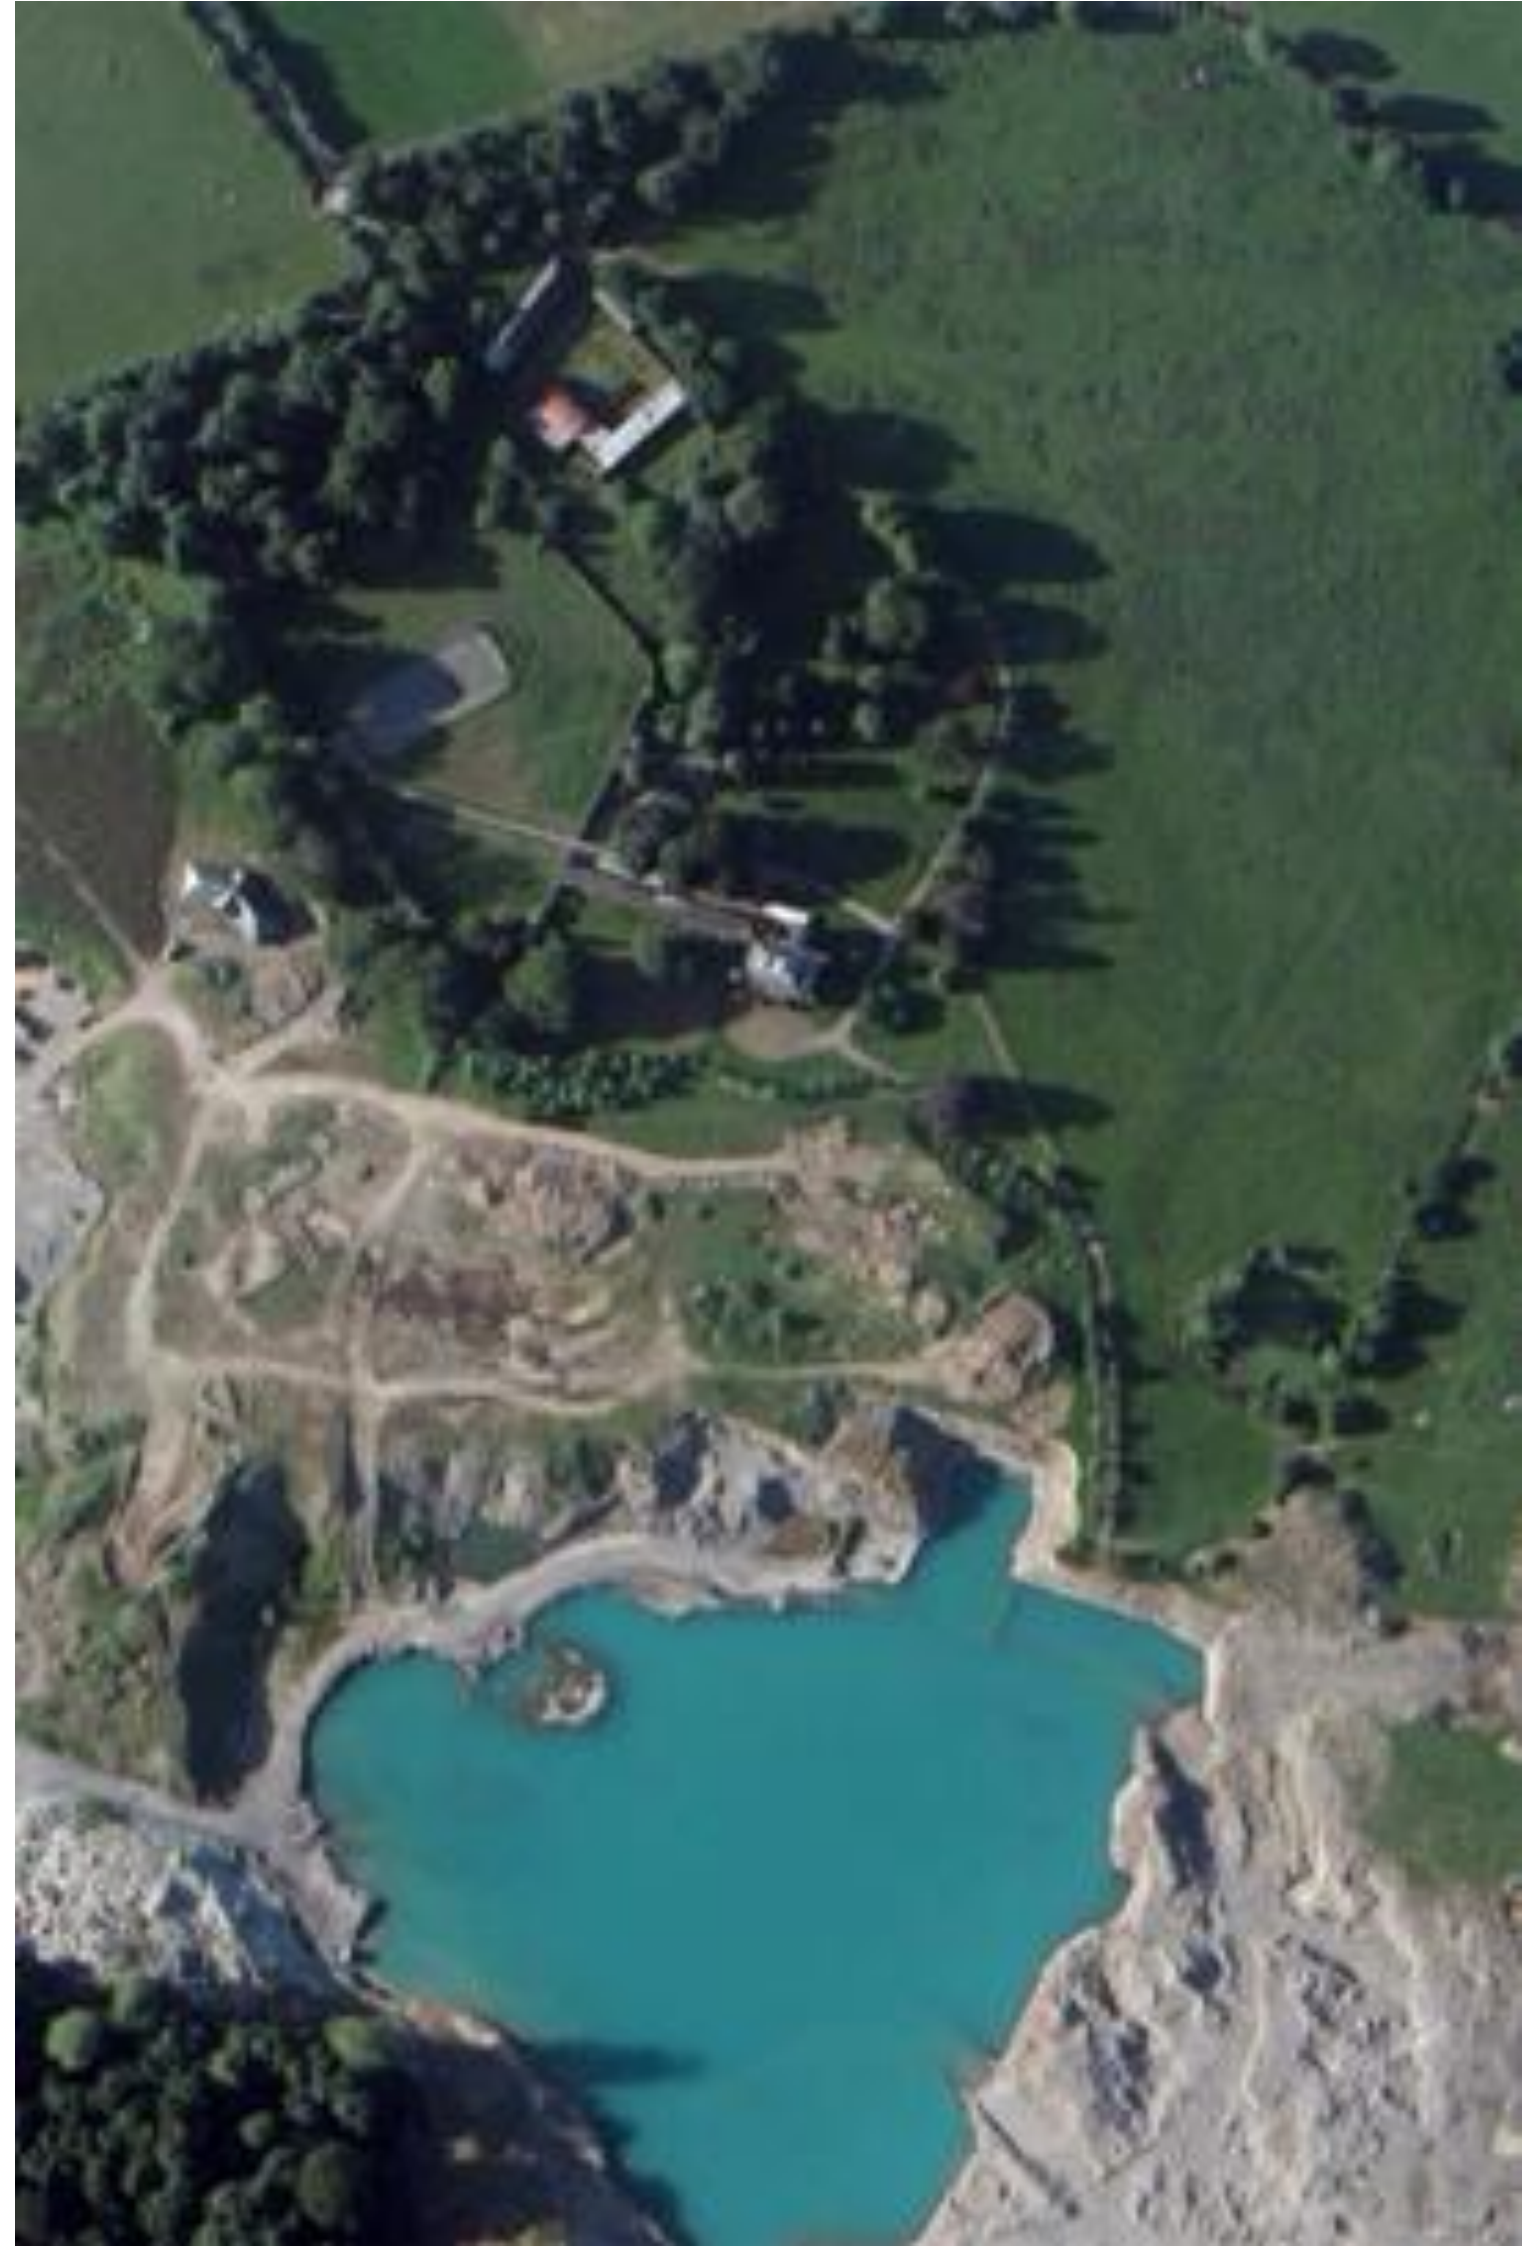
Williamstown House

Vacant with no identified new use	
Suffering from neglect and/or poor maintenance	X
Suffering from structural problems	
Fire damaged	
Threatened with demolition	
Ruin which is poorly maintained	X

Condition of Structure	Ruinous
Level of Risk	High

The building is a roofless shell. None of the original fabric remains other than the external walls. It is suffering from structural problems that could lead to full or partial collapse, and there is an immediate threat of further deterioration.

Williamstown is a three storey over basement, nine bay house in a parkland setting. It was originally a five bay house but the central portion was extended by two bays to each side circa 1830 with ashlar limestone, brilliantly cut to match the original. The structure is of significant historic importance and requires conservation works to prevent further deterioration.

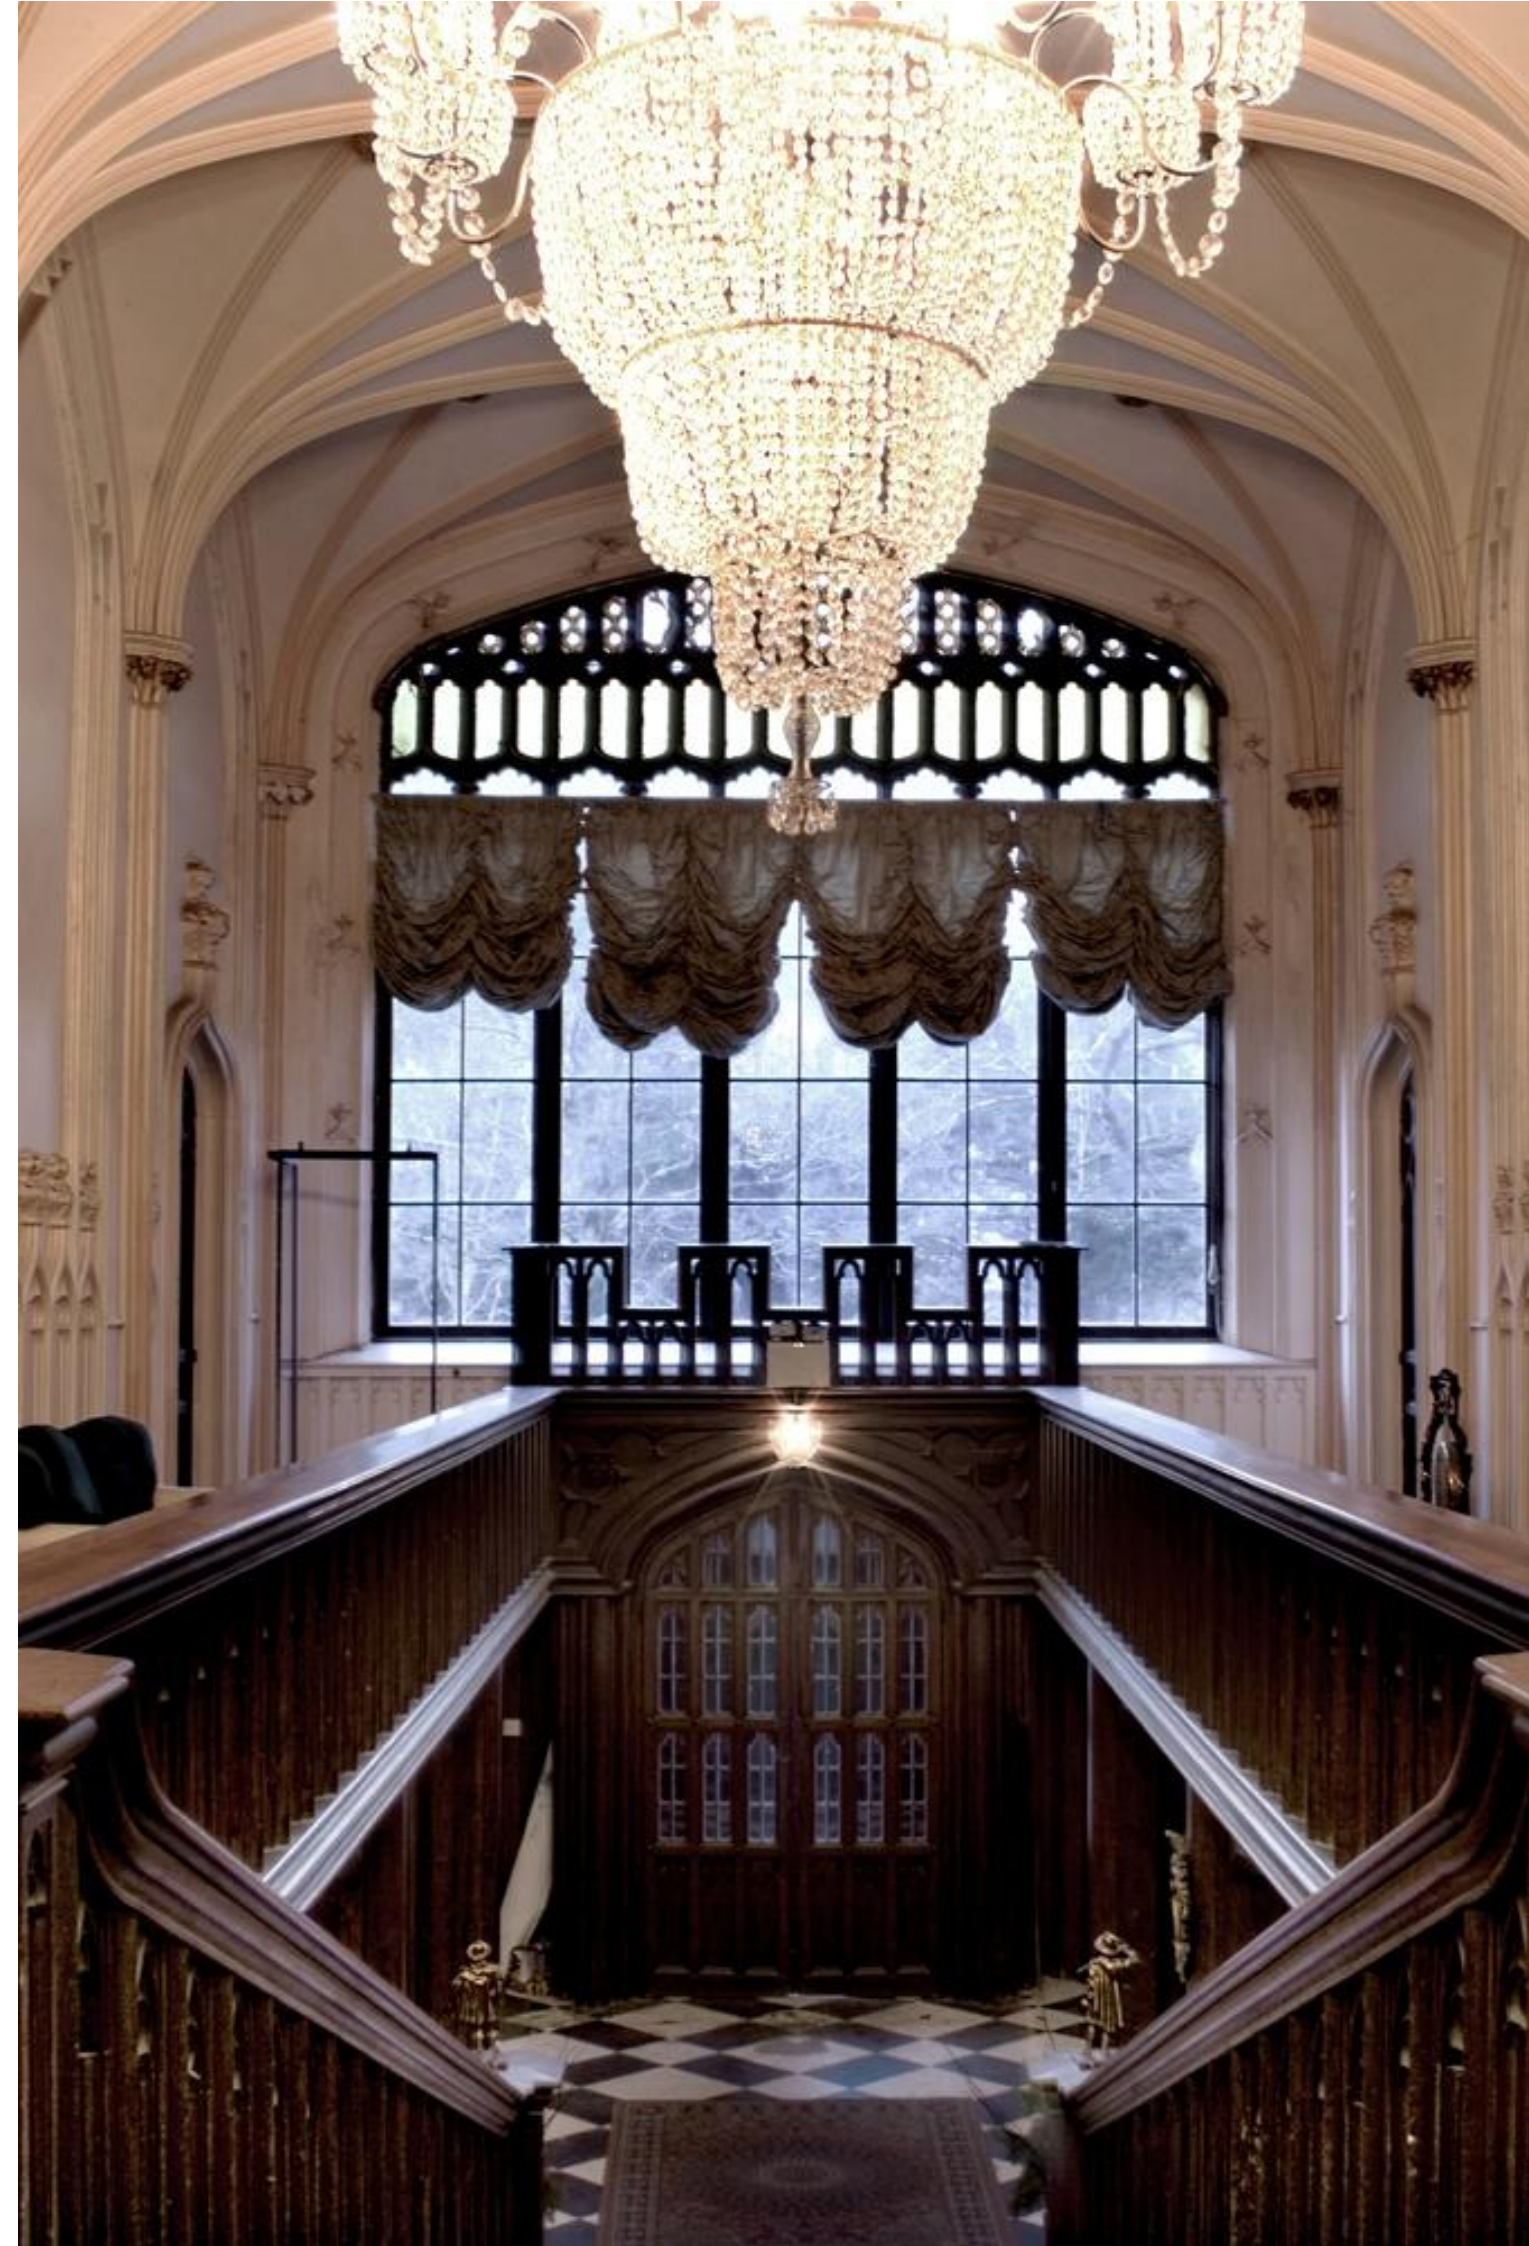
Lough Key Arch

Vacant with no identified new use	X
Suffering from neglect and/or poor maintenance	X
Suffering from structural problems	
Fire damaged	
Threatened with demolition	
Ruin which is poorly maintained

Condition of Structure	Fair
Level of Risk	High

The main entrance to the Lough Key Demesne which contained one of Ireland's finest houses designed by John Nash and gutted by a fire in 1950. One of the most impressive of Irish gateways in the form of two storey gothic structure with entrance arch and flanking single storey wings. The arch is in Coillte ownership as part of the Forest Park. It has been poorly maintained in recent years. The structures are of significant historic importance and require conservation works to prevent further deterioration.

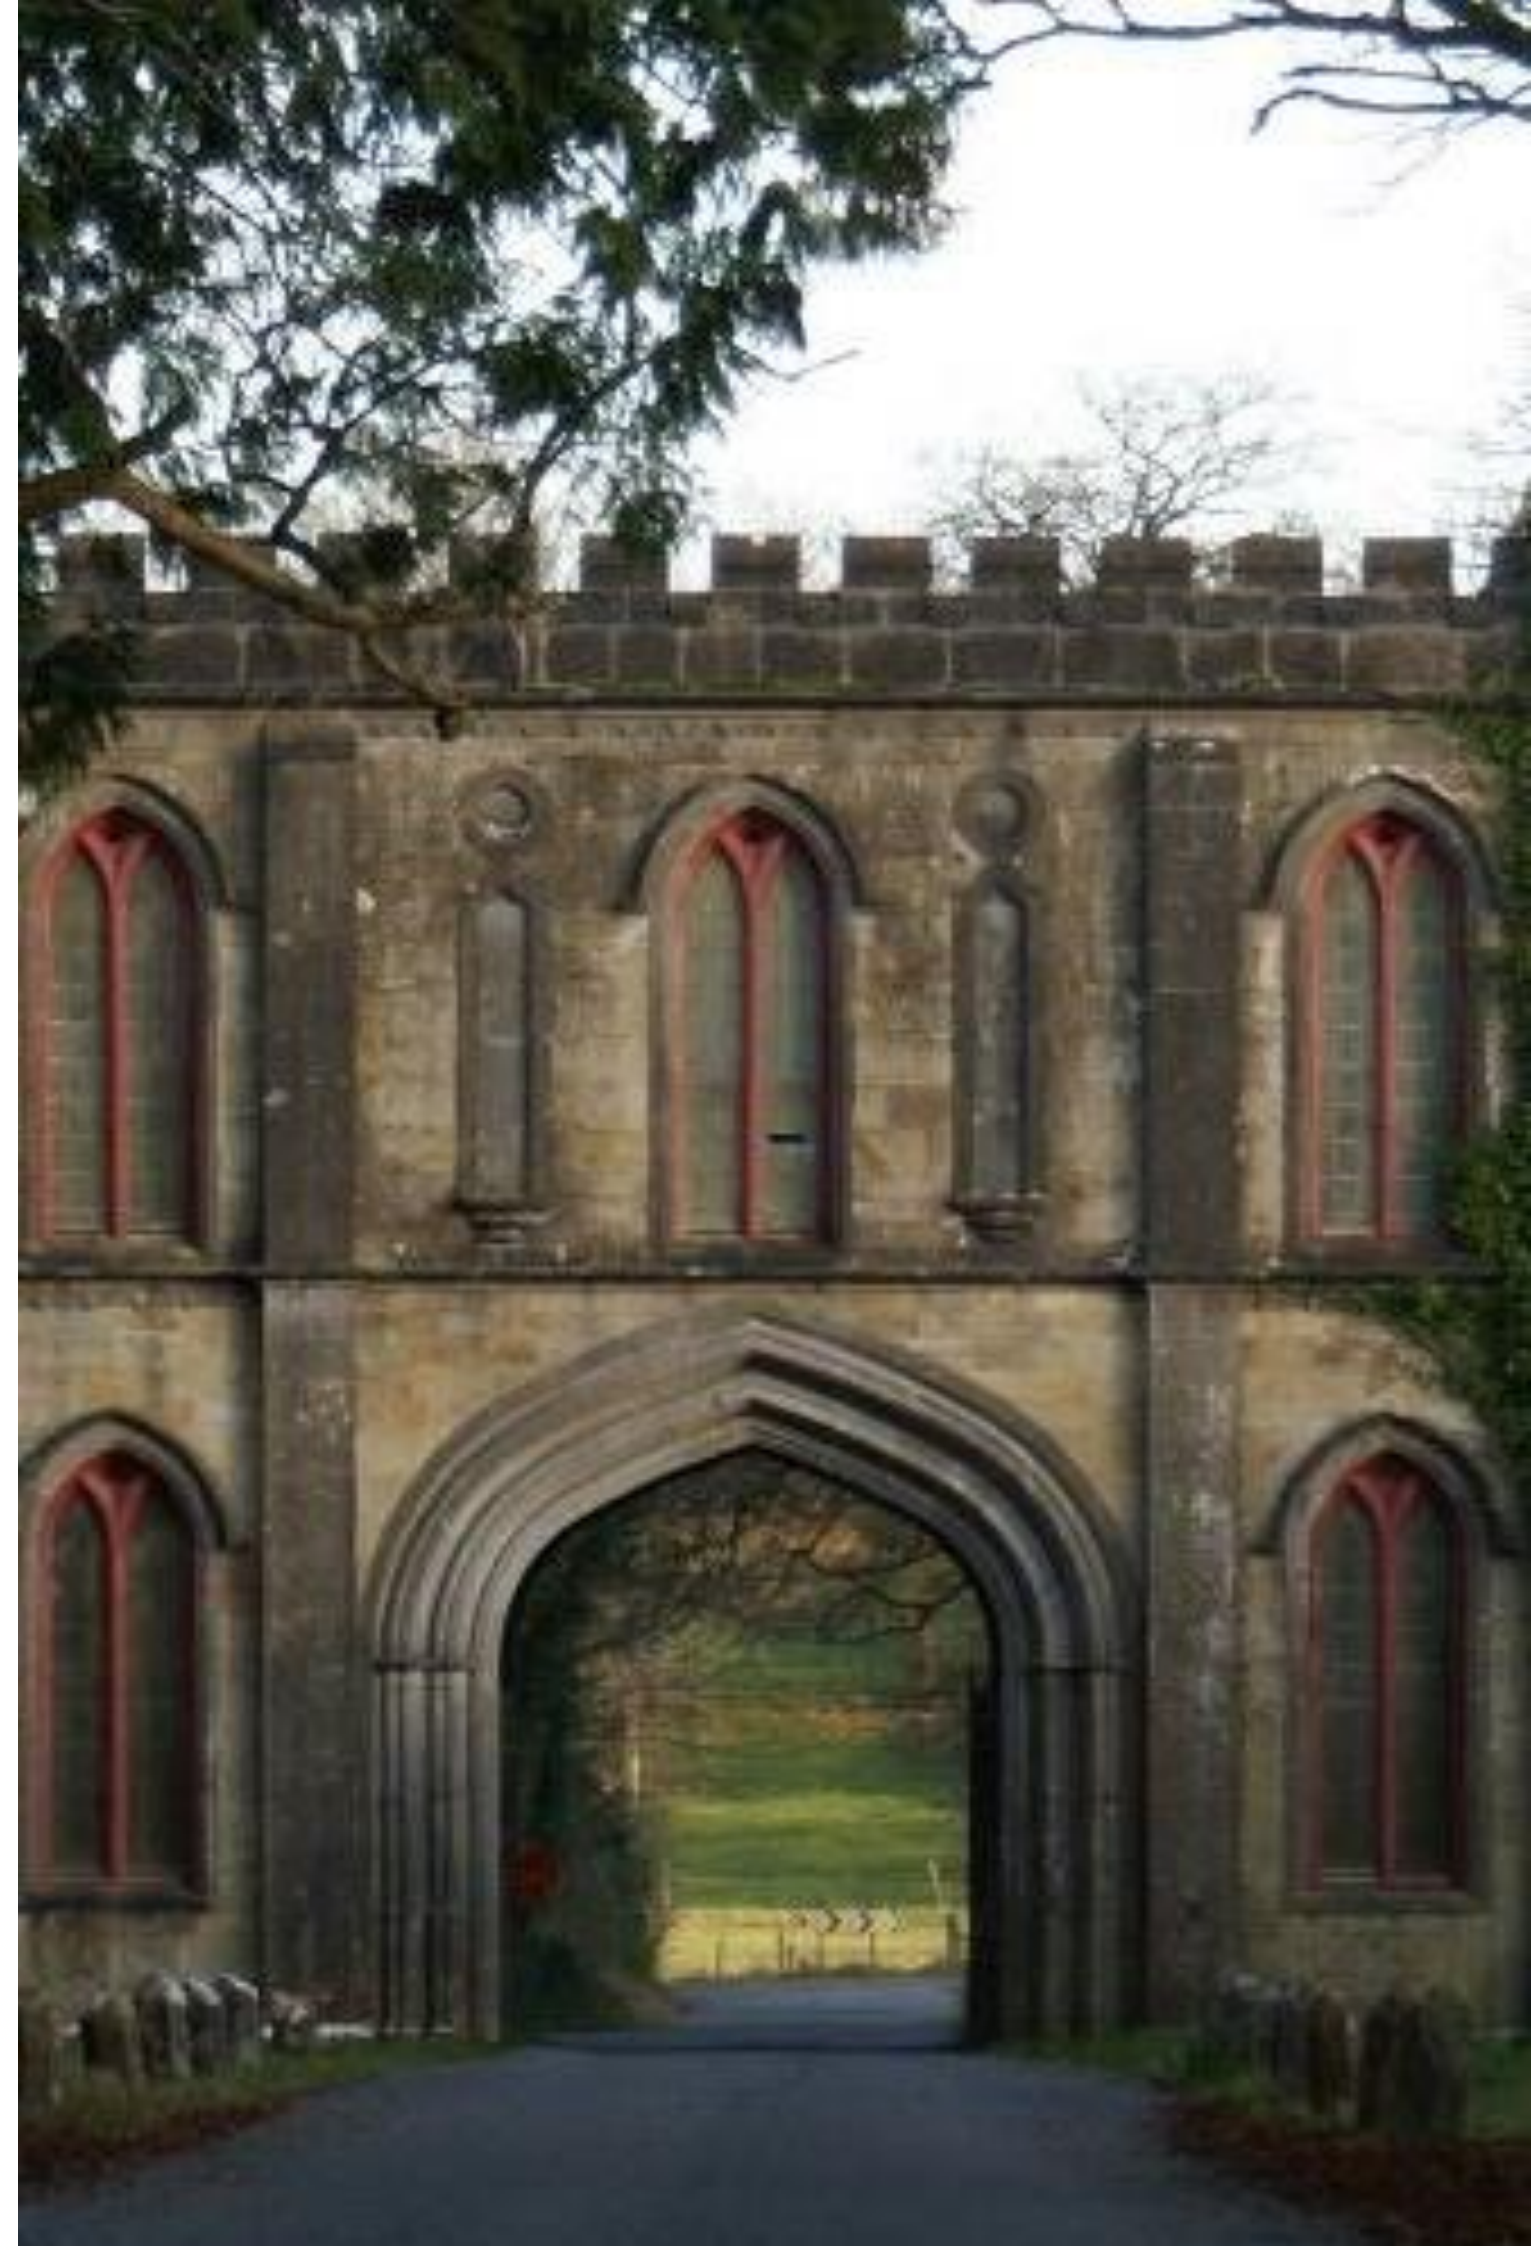
Loughglynn Convent

Loughglynn is a former convent and nursing home but was originally a country house built circa 1715 and extended circa 1820. It was originally a three storey structure, the top floor was removed following a fire in the early 20th century. There are limestone walls, bay windows facing the rear garden and replacement windows throughout. This building urgently requires new uses to be identified to prevent further deterioration of its character.

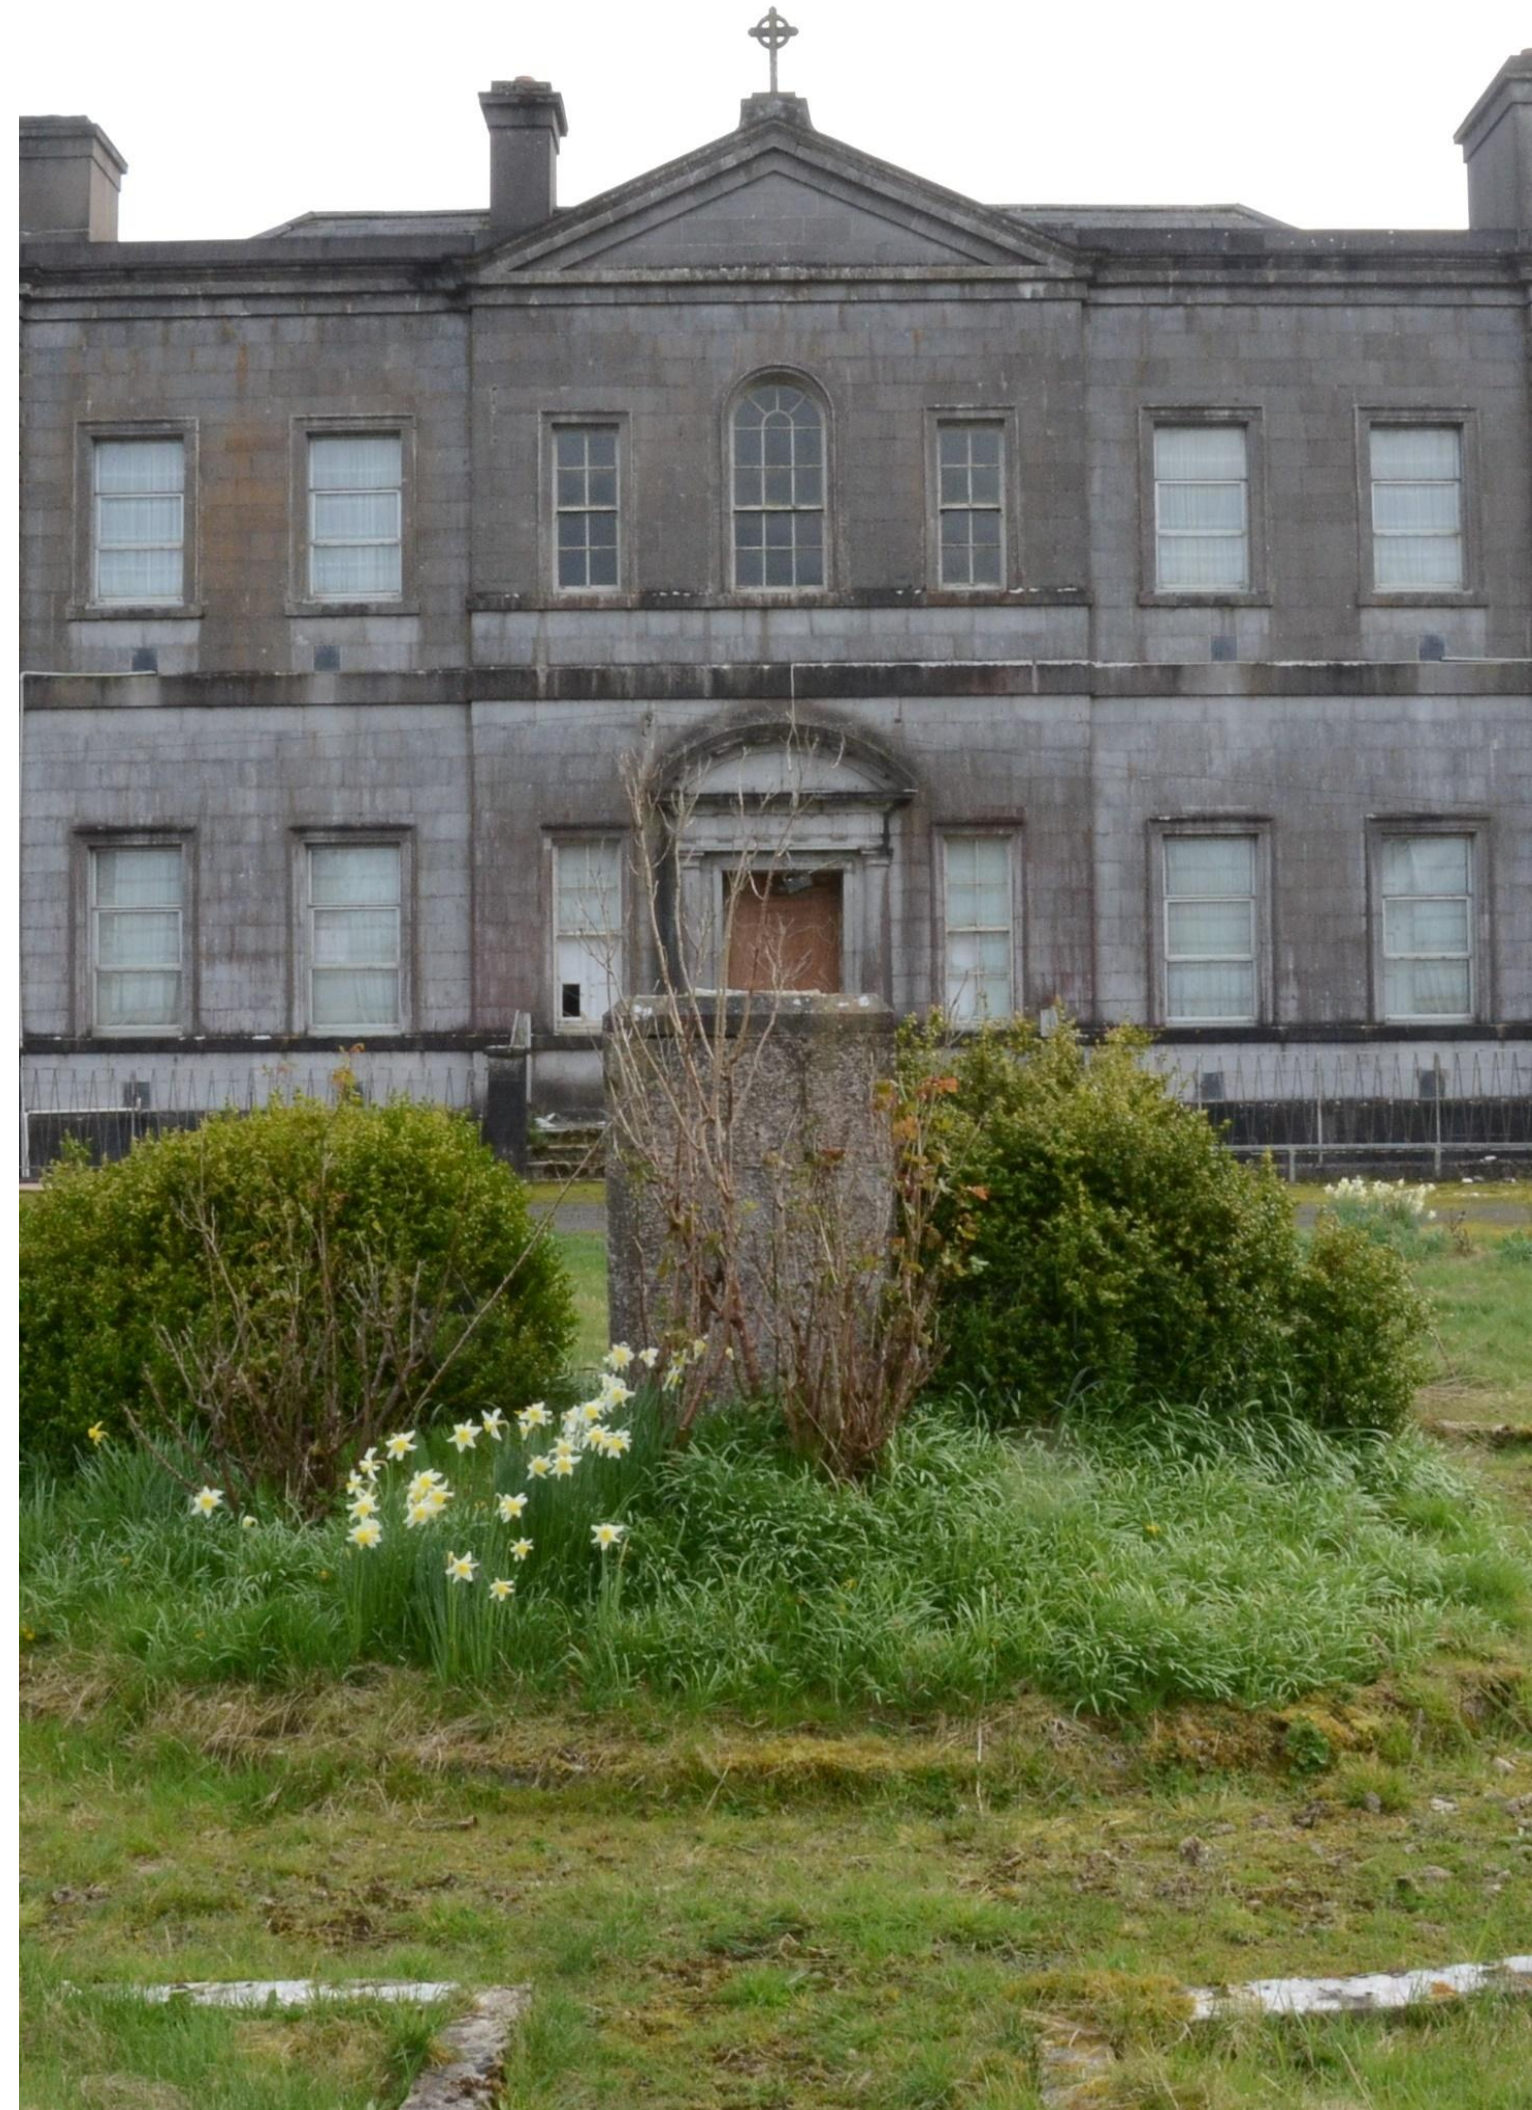
Mote Park Gate

One of the most impressive country house gates in Ireland now leading to site of demolished house. The monumental doric archways, circa 1800, surmounted by plinth and stone lion require a conservation plan to secure the structure and sculptures to prevent further deterioration.

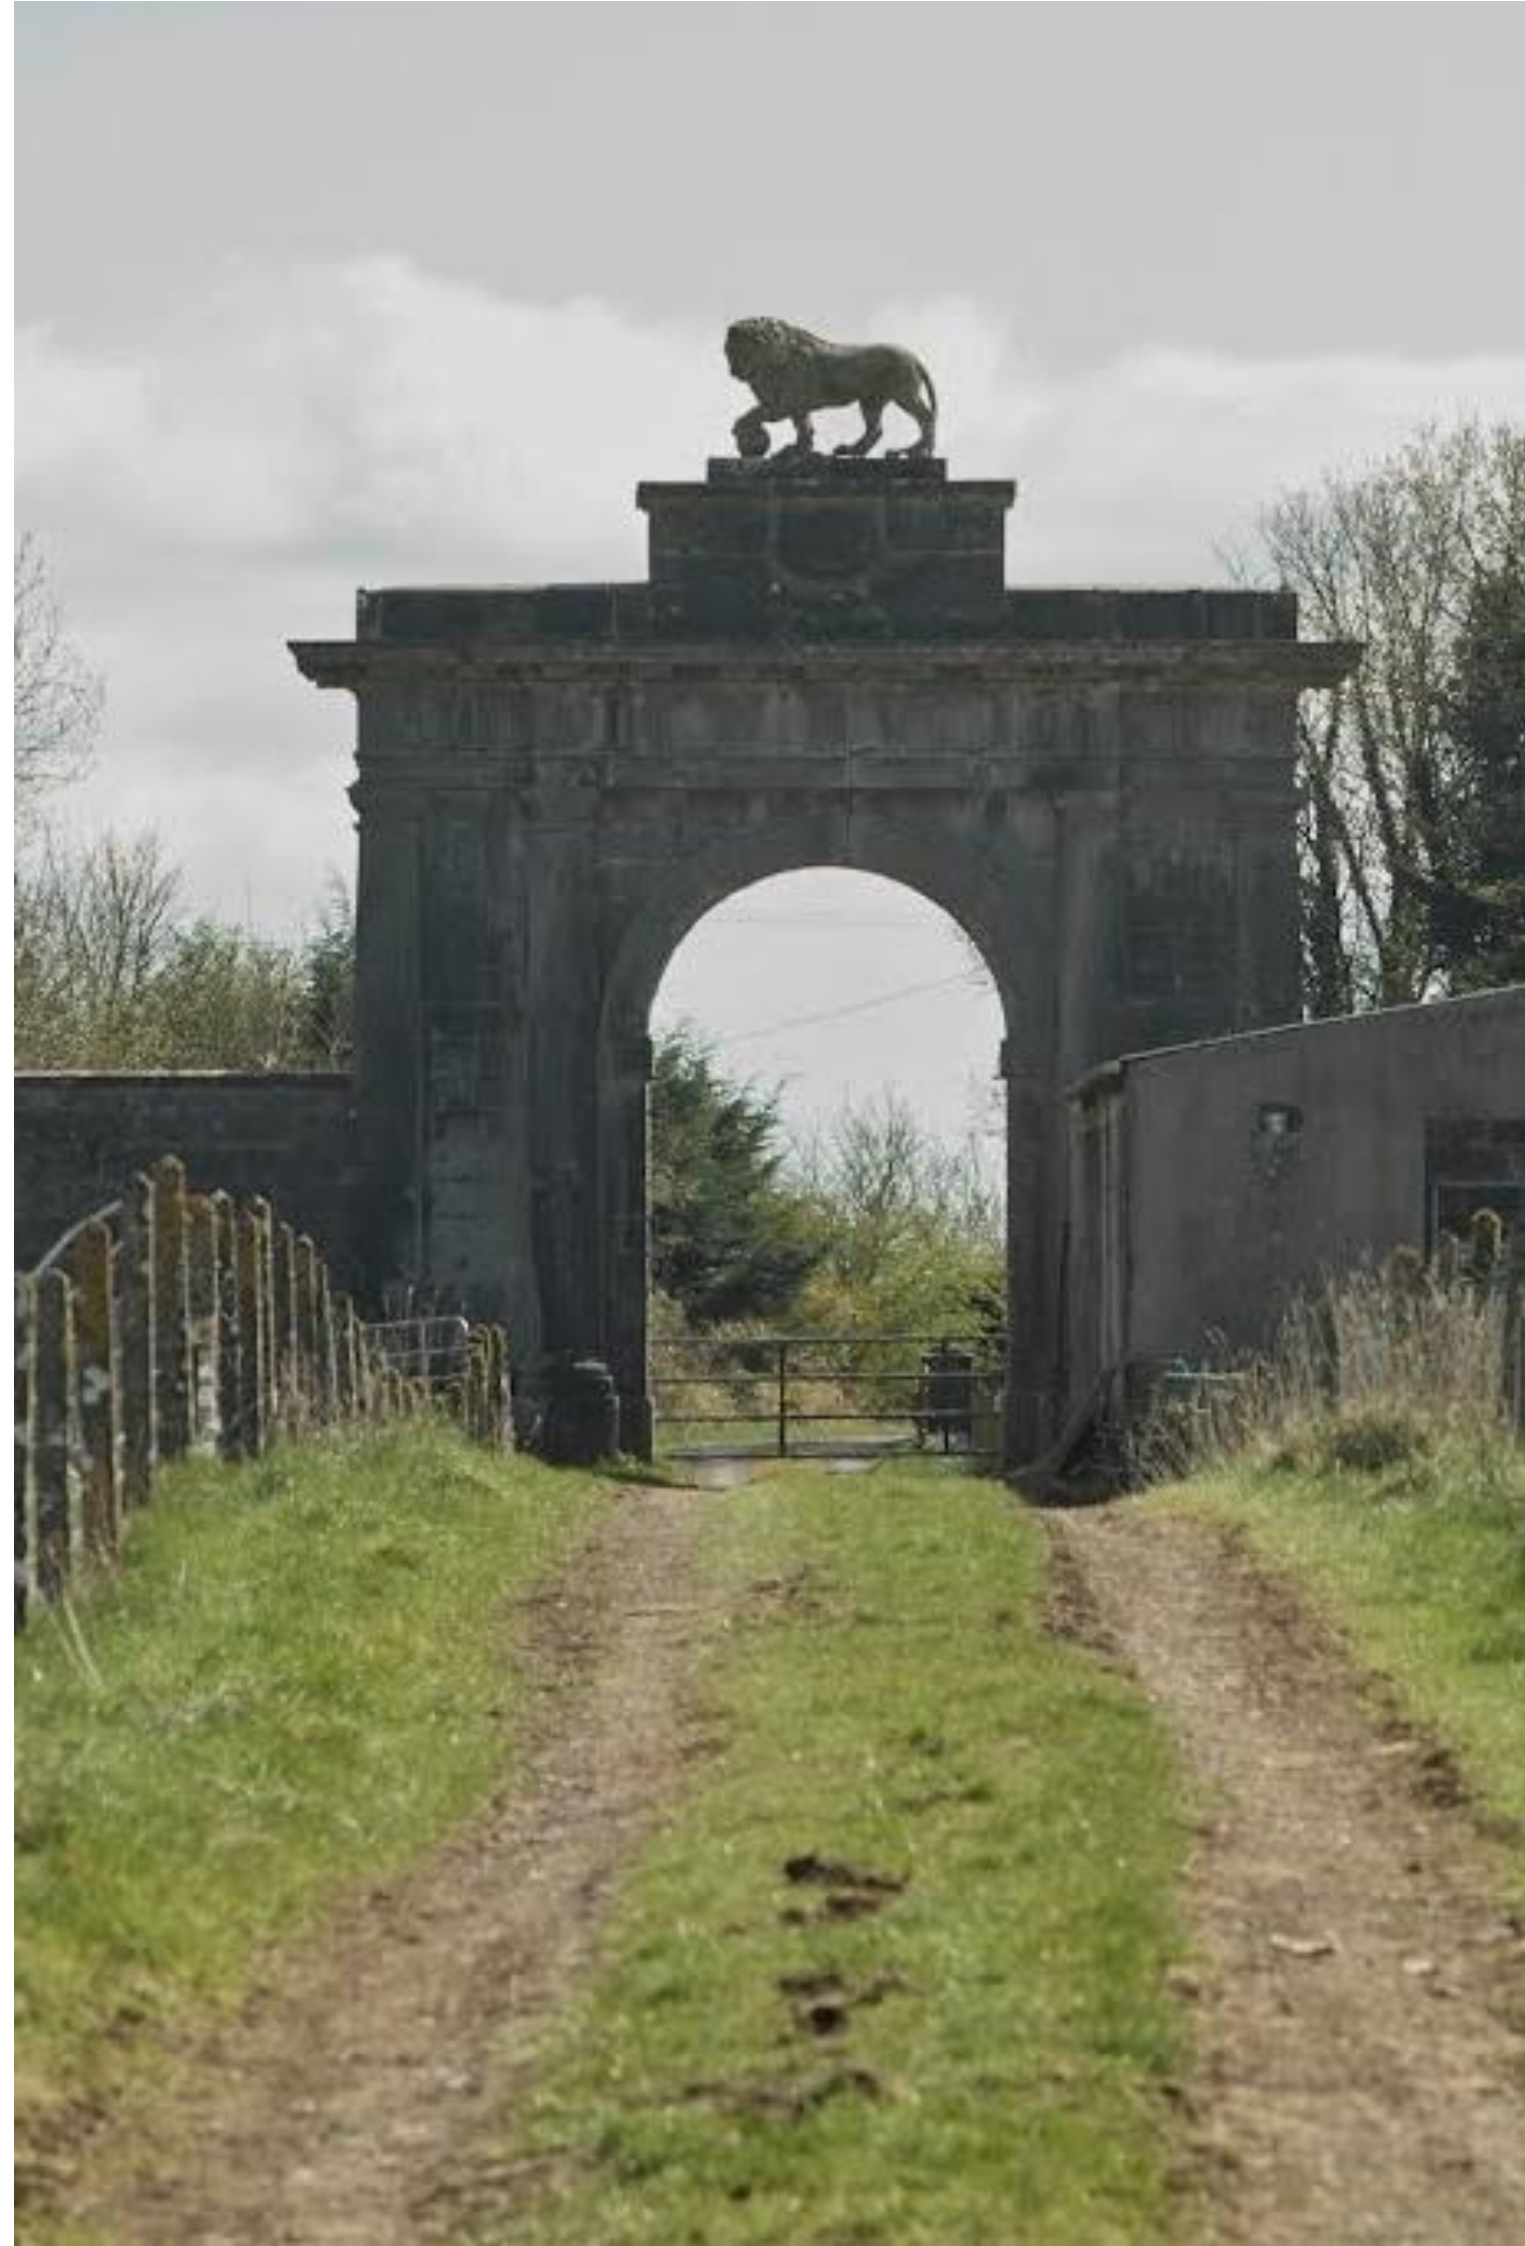
Hazelwood House

It is a three storey over basement house with curved quadrants linking wings designed by Richard Castle circa 1731 for Owen Wynne MP. Distinguished scheme of interior decoration ranking among the best surviving suite of rooms of this period in Ireland. An intrusive factory building constructed by Italian nylon fibre manufacturing firm Snia in 1960s between main house and lake. From 1980's it was the location of Korean video manufacturing company Saehan. The house is poorly maintained over a number of decades. There was €100,000 Heritage Council grant money recently awarded towards roof conservation. Proper use and management of house remains unresolved. An Bord Pleanála refused major housing scheme in grounds, upholding Sligo County Council refusal. The property is currently for sale. This building urgently requires new uses to be identified to prevent further deterioration of its character.
